Aerodyne Research LLC
1407 Flightline Blvd. Unit 14
Deland FL 32724 USA

Icon Reserve Pilot Chute Failed to Clear Side Flaps, Ser #IN-I5-12509, DOM Sep 2008

Regarding test-report for pilotchute hesitation on Icon I5 SN#12509

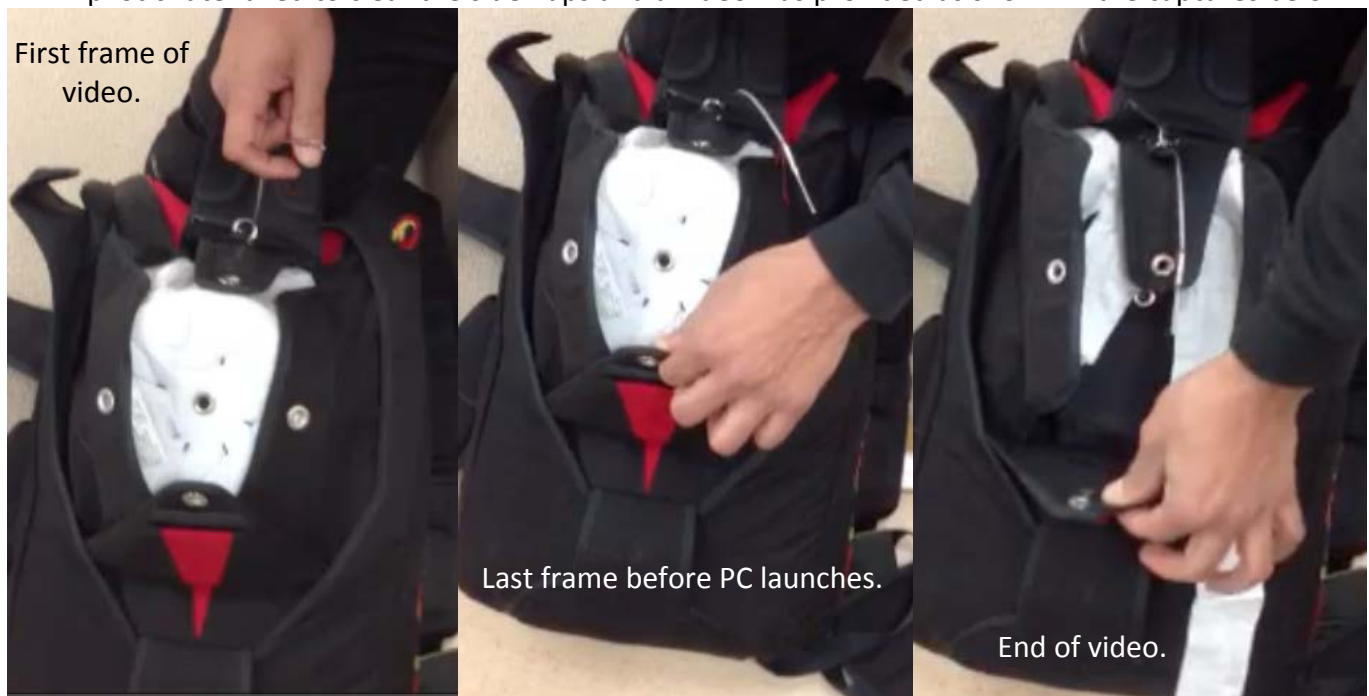
19 November 2012 it was reported that when the pin was pulled for routine repack, the reserve pilot chute failed to clear the side flaps and a video was provided as shown in the captures below.

It was noted from the provided video that the rig was not being worn and the pin was not pulled by its handle. The video shows that it was sitting on the ground and appears to have been pulled by the cable close to the pin, this would mean that this rigger's hand had to have contacted the #5 flap once the pin was clear of the loop interfering with its normal activation.

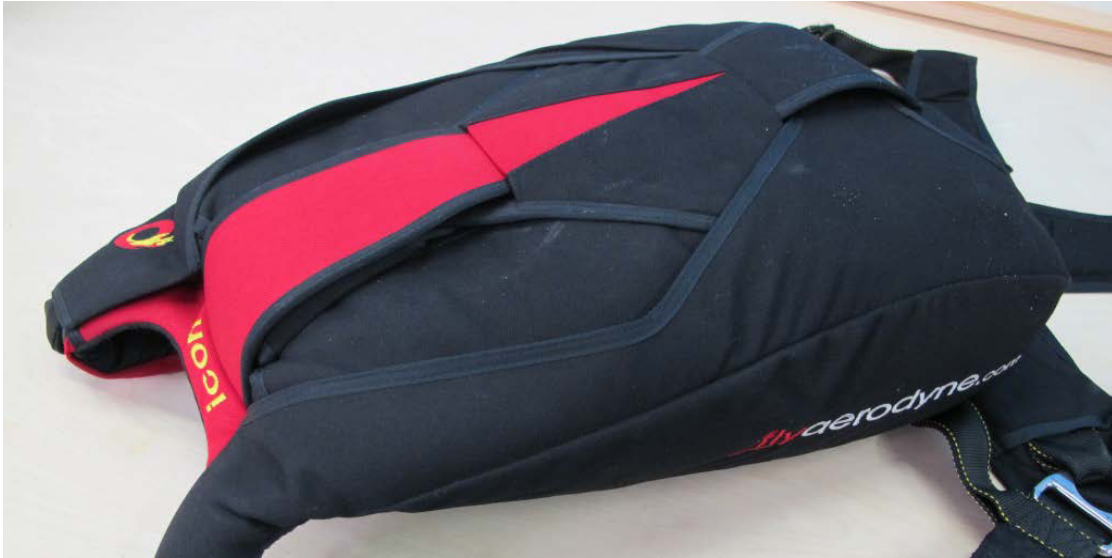
The rig arrived 29 November 2012 with the reserve closed as shown below and the first observation was that the loop was on the excessively long side and the reserve PC was not at full compression.

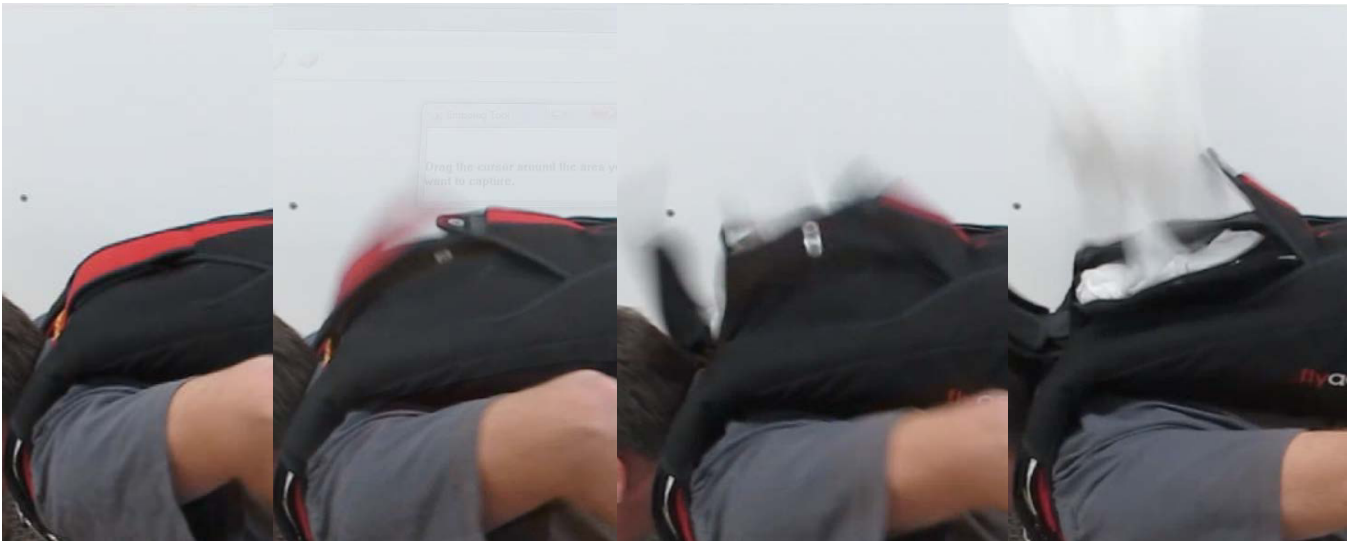
The rig was then test pulled exactly as it arrived. A good launch with no hesitation was observed. See captured video below. Video provided upon request.

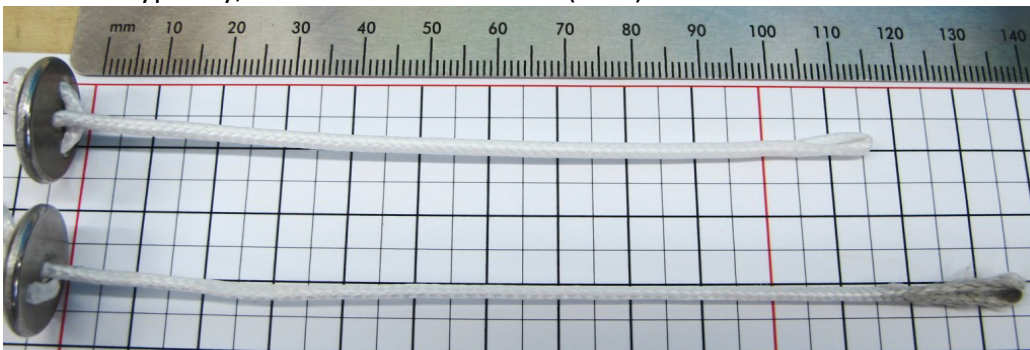
← Actual loop taken from I5 #IN-I5-12509.

After opening, the loop measured to be 137mm (5 3/8"), this is common length used here on tandem reserves. Typically, we would use a 115mm (4 1/2") with this combination.

Judging by the customer provided video, it would appear an anomaly was produced from 2 contributing factors, one being an excessively long reserve closing loop and the other from initiating reserve deployment in an unconventional manor. After completing the 15 successful test pulls we do not feel any corrective actions are necessary.

Riggers in the field should note that when opening a reserve for its scheduled repack that all manufacturers advise that it should be worn on the shoulders and actuation initiated by ripcord handle.
